PERFORMANCE DATA FOR SOME  
BITUMINOUS CONCRETE OVER-  
LAYS IN INDIANA

Joint  
Highway  
Research  
Project

by  
W. H. GOETZ  
J. F.  
MC LAUGHLIN

File: 2-11-3  
Project No. C-36-31C

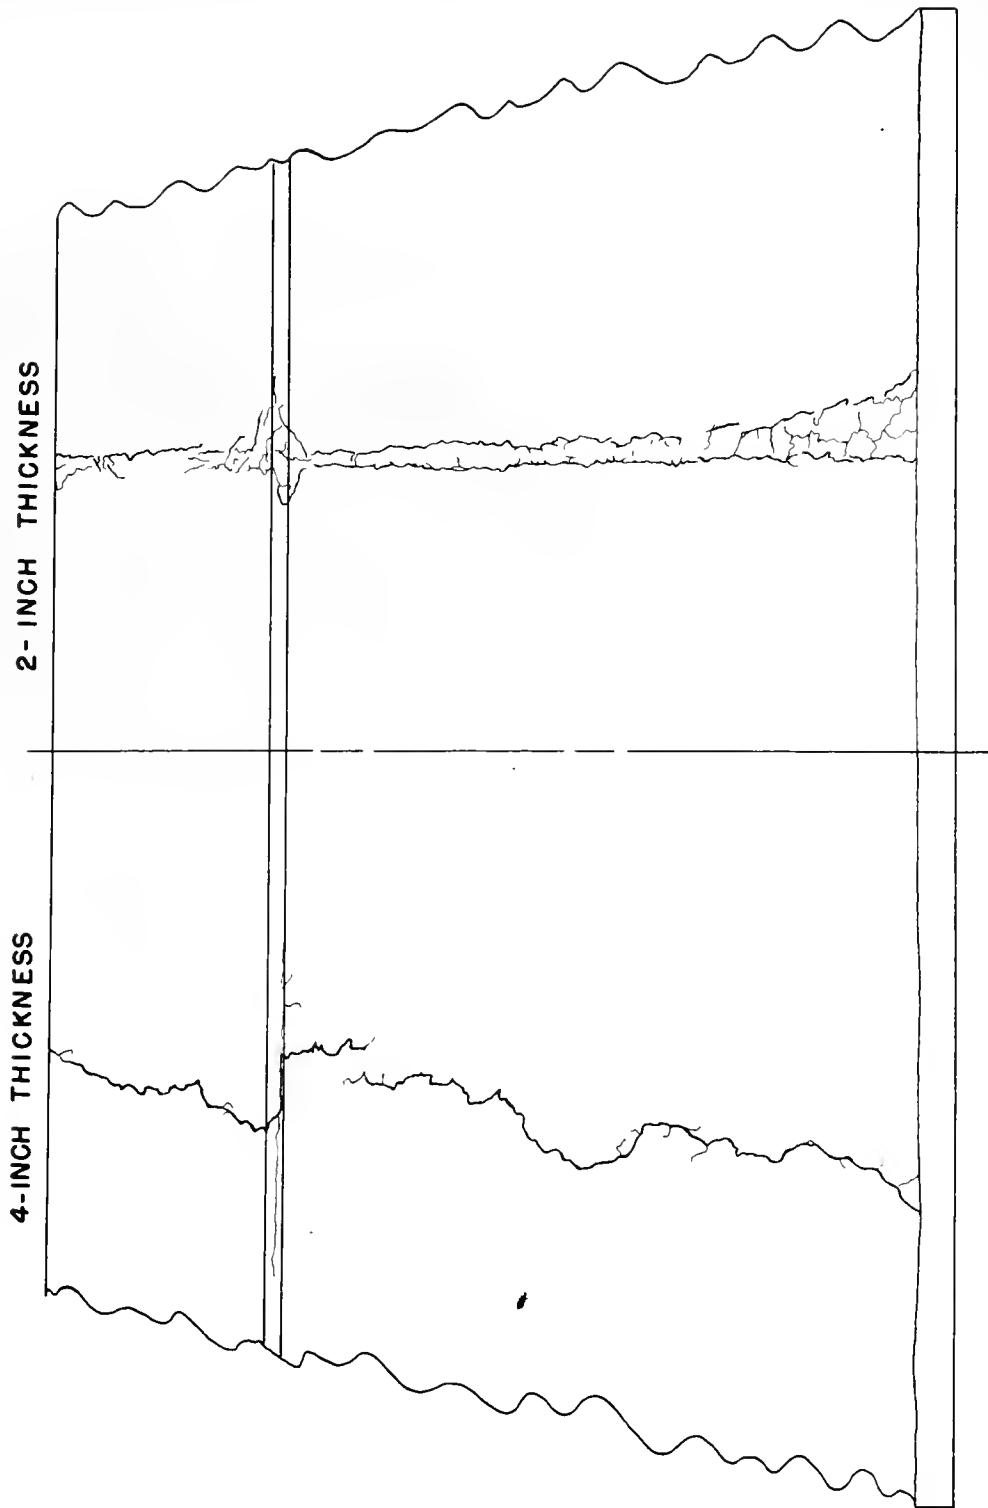
FIG. 2

All thickness designs on this road did not perform equally and there is evidence that heavy lays may be advantageous for some conditions. In Figure 2, for example there is shown for the jointed concrete pavement a "typical" reflection crack in the four-inch thick overlay on the left compared to a typical one in the two-inch thick overlay on the right. The crack in the two-inch thick overlay is more severe. It follows along the line of the joint and really is a system of multiple cracks with chunks of bituminous-concrete mixture beginning to be cracked off. The crack in the four-inch thick overlay, however, is a meandering one. It is, for the most part, a single crack and there are no signs of ravelling associated with it.

COMPARISON OF PERFORMANCE OF 2" AND 4" THICK  
OVERLAY ON JOINTED CONCRETE  
SR 37

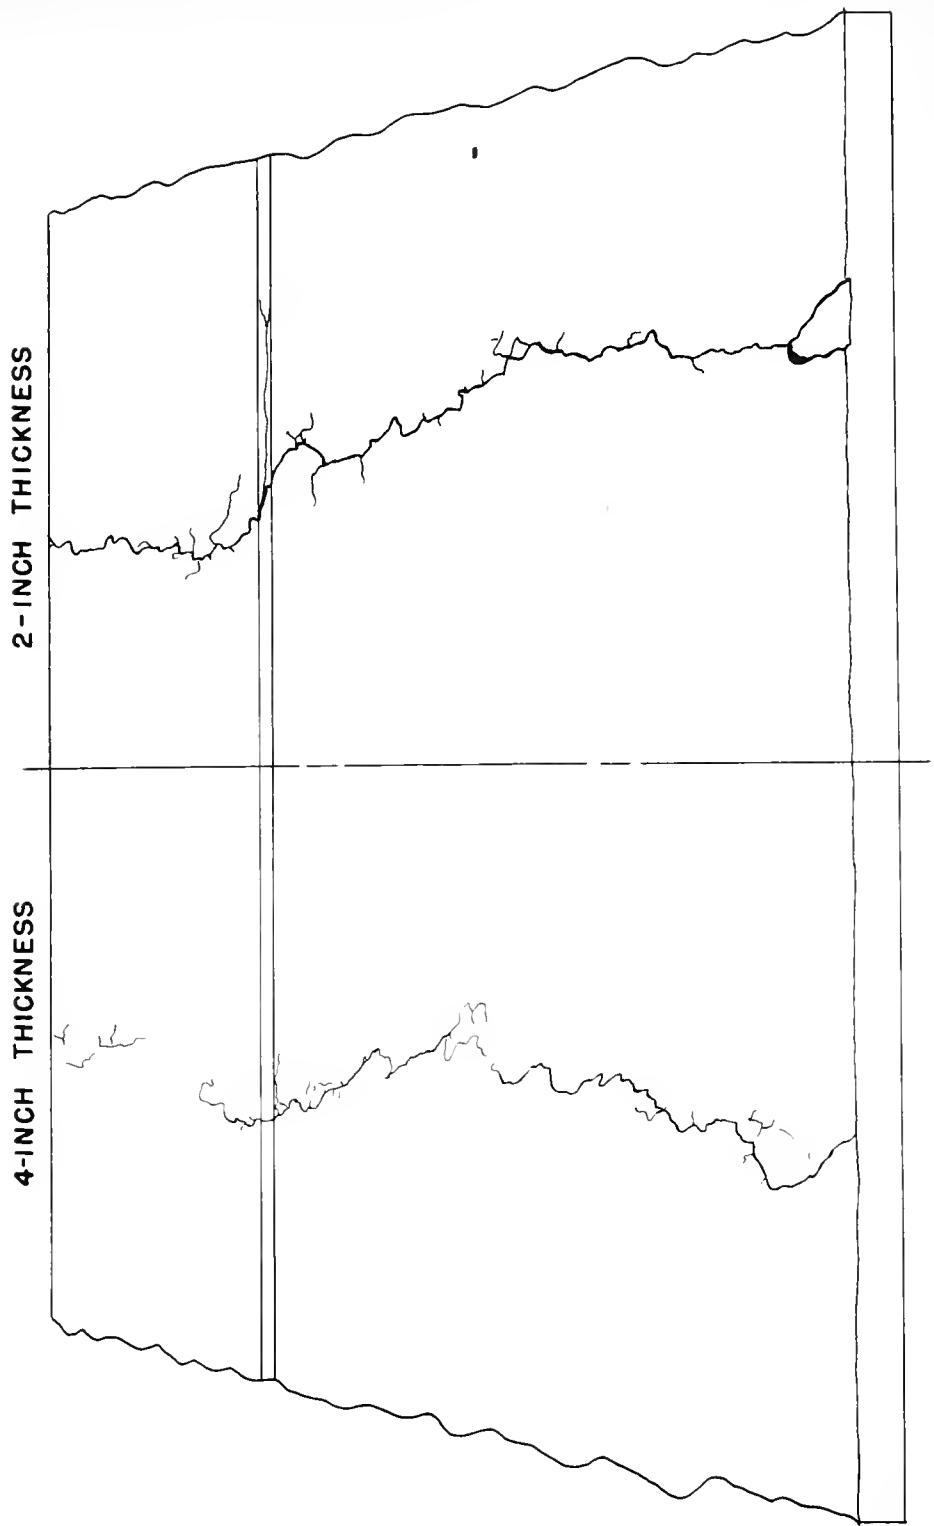
FIG. 3

Figure 3 shows a similar comparison for the bituminous-concrete overlay placed on the concrete pavement without transverse joints. This concrete has a fairly short crack interval. Before and after surveys indicated that most of the cracks in the concrete were reflected in the overlay. It may be seen from Figure 3, however, that these cracks are generally much less severe than those in the jointed concrete section. Again, the performance of the four-inch thick overlay is compared with the two-inch thick one with the four-inch thick section on the left. The condition of the cracks indicates some advantage for the thicker lay. But the difference is not as great as for the case with jointed concrete pavement.

COMPARISON OF PERFORMANCE OF 2" AND 4" THICK OVERLAY  
ON NON-JOINTED CONCRETE  
SR 37

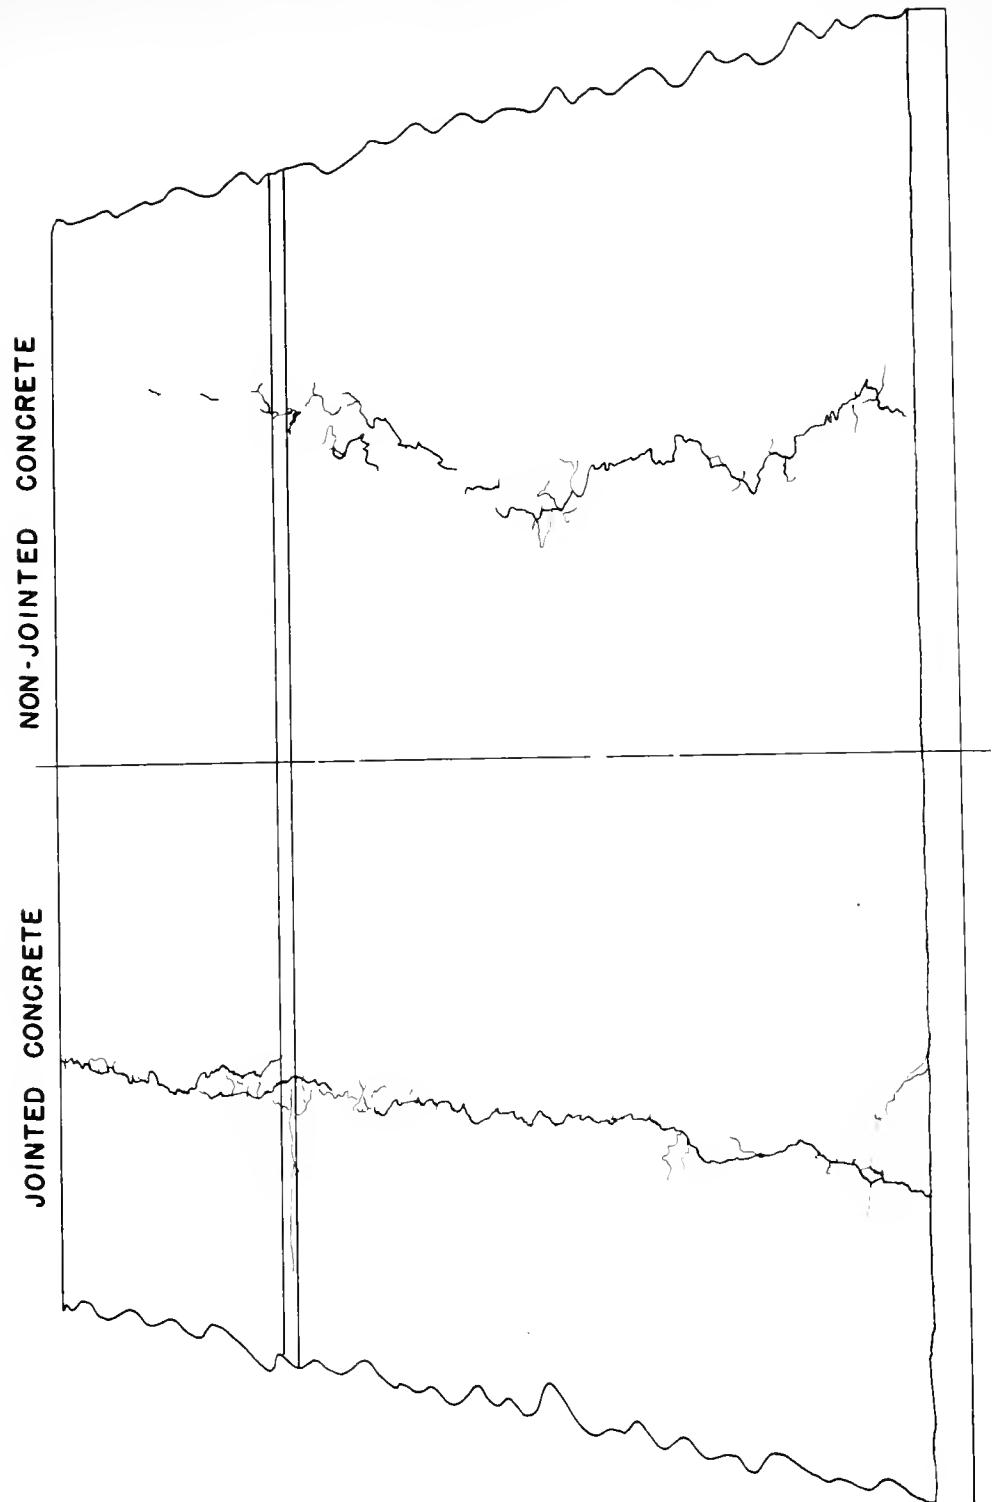
FIG. 4

A comparison between the performance of the three-inch thick overlay on jointed and non-jointed concrete is shown in Figure 4. The jointed concrete is on the left and the non-jointed concrete is on the right. For this thickness, which is very close to the standard design for the road, it is seen again that reflection cracking is less severe over non-jointed concrete.

COMPARISON OF PERFORMANCE OF 3-INCH THICK, OVERLAY  
ON JOINTED AND NON-JOINTED CONCRETE  
SR 37

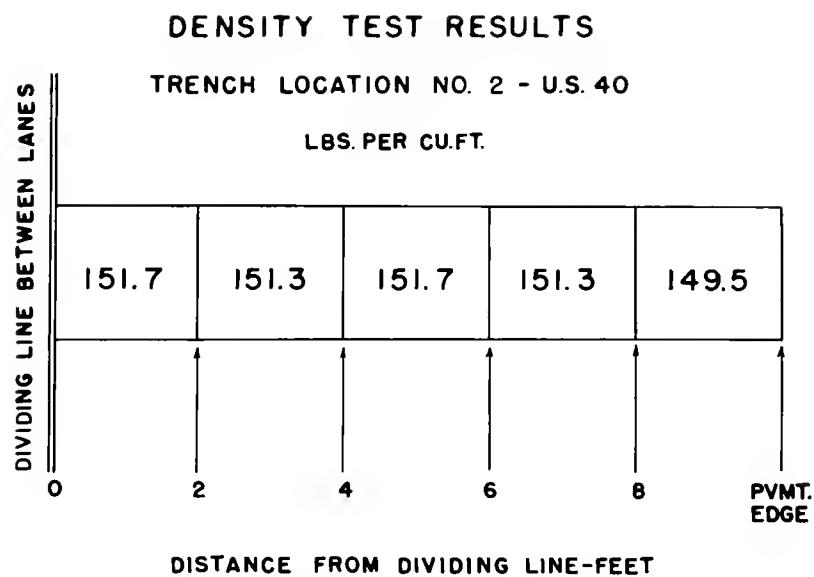
Figure 9.

extended some six inches beyond the edge of the concrete to which it was placed during construction. Secondly, it was found from an examination of the sawed face that both the binder and surface layers were distorted in the wheel-track areas. Thirdly, and this is illustrated in Figure 9, it was found from density measurements made on samples taken at closely-spaced intervals across the traffic lane that the density of the mixture was essentially the same regardless of sample writing.

In Figure 9 are grouped the density data for three 6" intervals across the trench. The low value that may be seen in the pavement diagram includes some samples that were obviously under-compacted.

All of these facts lead to the conclusion that the failures under consideration were caused by plastic flow. The realization of these failures and their nature lead the Indiana Highway Department to modify their bituminous concrete by several approaches. Aggregate content generally has been reduced in both the binder and surface layers. In some instances, the maximum aggregate size of the binder has been increased and the thickness of this layer increased with a corresponding decrease in surface-layer thickness. In other instances the ratio of coarse aggregate to fine aggregate has been increased in both the binder and the surface. Perhaps these modifications will provide the solution. There have been overlays built incorporating one or more of these modifications which appear to be performing quite satisfactorily at the present time under severe service conditions.
